DEPARTMENT OF TRANSPORTATION**DIVISION OF ENGINEERING SERVICES**

Contract #: 04-0120F4Cty: SF/ALA Rte: 80 PM: 13.2/13.9File #: 69.28**WELDING INSPECTION REPORT****Resident Engineer:**Siegenthaler, Peter**Address:** 333 Burma Road**City:** Oakland, CA 94607**Report No:** WIR-021667**Date Inspected:** 11-Mar-2011**Project Name:** SAS Superstructure**OSM Arrival Time:** 1900**Prime Contractor:** American Bridge/Fluor Enterprises, a JV**OSM Departure Time:** 700**Contractor:** Zhenhua Port Machinery Company, Ltd (ZPMC), Changxing Island **Location:** Shanghai, China**CWI Name:** See Below**CWI Present:** Yes No**Inspected CWI report:** Yes No N/A**Rod Oven in Use:** Yes No N/A**Electrode to specification:** Yes No N/A**Weld Procedures Followed:** Yes No N/A**Qualified Welders:** Yes No N/A**Verified Joint Fit-up:** Yes No N/A**Approved Drawings:** Yes No N/A**Approved WPS:** Yes No N/A**Delayed / Cancelled:** Yes No N/A**Bridge No:** 34-0006**Component:** OBG**Summary of Items Observed:**

OBG Bay 14.

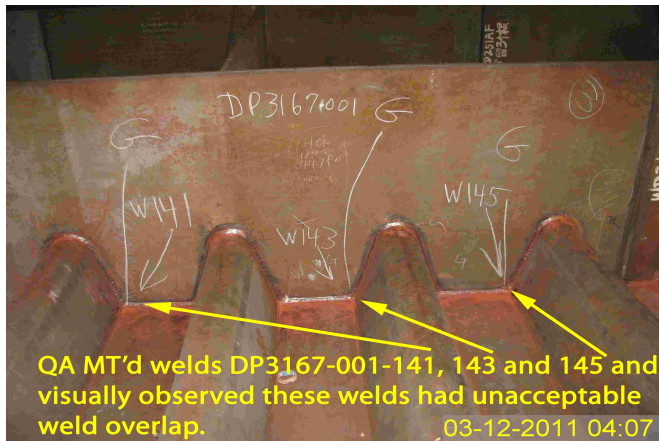
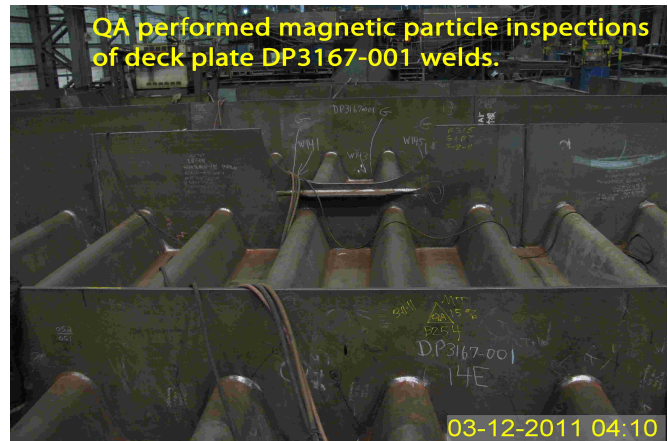
This QA Inspector performed random magnetic particle (MT) inspections of segment 14E deck plate welds DP3167-001-019~024, 409~417, 194, 195, 197, 198, 377, 378, 385, 386, 393, 394, 401, 415, 417, 423,210, 211, 218, 219, 226, 227, 234, 235, 248, 249, 256, 257, 264, 265, 272, 273, 291, 292, 299, 300, 307, 308, 315, 326, 334, 335, 342, 343, 350, 351, 358, 39, 207, 208, 280~289, 323~332, 366, 375, 082~093, 136~147, 199~206, 043,044, 051, 052, 059, 060, 067, 068, 075, 076, 095, 096, 103, 104, 111, 112, 119, 120, 127, 128, 149, 050, 157, 058, 169, 170, 177, 178, 189, 190, 191, 192, 042, 046, 050, 053, 058, 061, 066, 069, 074, 077, 094, 097, 102, 105, 110, 113, 118, 121, 126, 129, 148, 151, 156, 159, 164, 165, 168, 171, 176, 179, 209, 212, 217, 220, 225, 228, 233, 236, 247, 250, 255, 258, 263, 266, 271, 274, 290, 293, 298, 301, 306, 309, 314, 317, 333, 336, 341, 344, 349, 353, 357, 360, 376, 379, 384, 387, 392, 395, 400 and 403, NWIT (NDT Inspection Notification Sheet) 8519 item #4. The NWIT listed above indicates welds DP3167-001-418~422 were also presented for MT inspections. This QA Inspector observed these welds do not appear to have been completed. This QA Inspector observed welds DP3167-001-141, 143 and 145 were visually unacceptable due to weld overlap at the toe of the weld. This QA Inspector was not able

to locate any ZPMC workers with grinding equipment to remove the weld overlap and dayshift QA Inspectors acknowledged they would have these areas of weld overlap removed. For additional information on these inspections see this QA Inspector's TL6028 magnetic particle test report and the photographs below.
